## COMMISSION FOR HISTORICAL & ARCHITECTURAL PRESERVATION

### STAFF REPORT

**REQUEST:** Demolition Hearing One – Determination of Architectural Significance

**ADDRESS:** 1135 Hollins Street (Union Square Historic District)

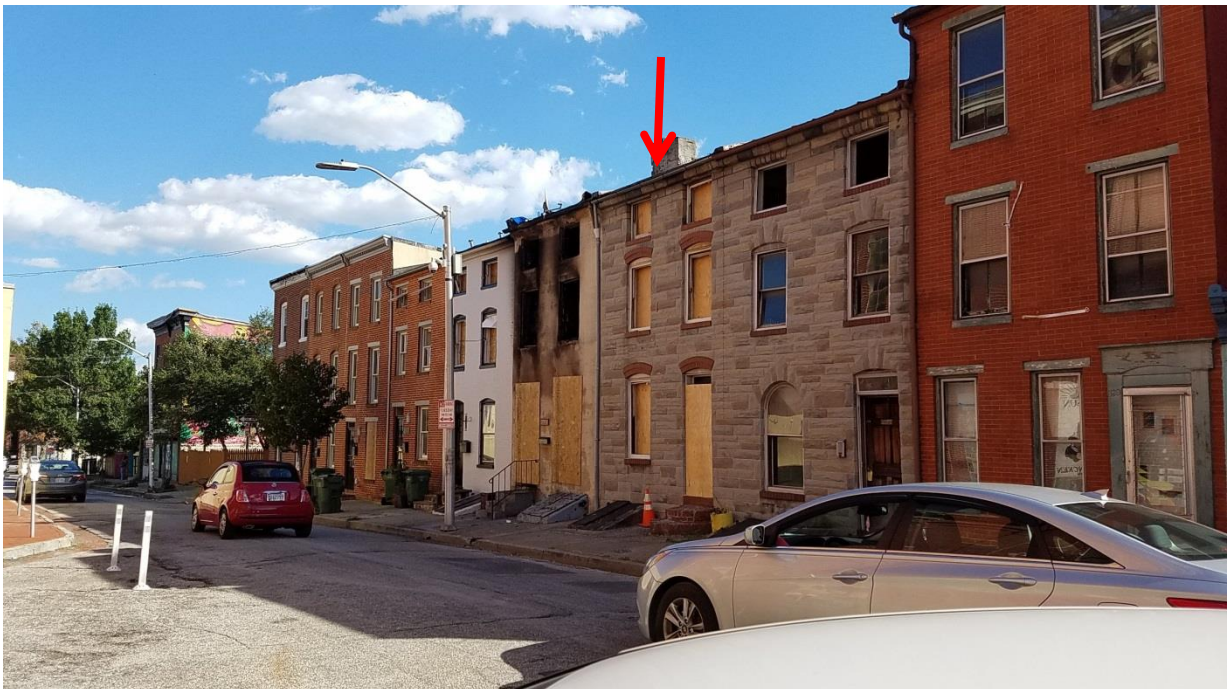
*Image 10: 1135 Hollins Street, January 22, 2019*

Before the applicant was able to carry out approved plans to rehabilitate 1135 Hollins Street, a fire which had started in 1133 Hollins Street severely damaged the building on October 16, 2018. Staff visited the site immediately after the fire, and also in January (*Images 10-13*).

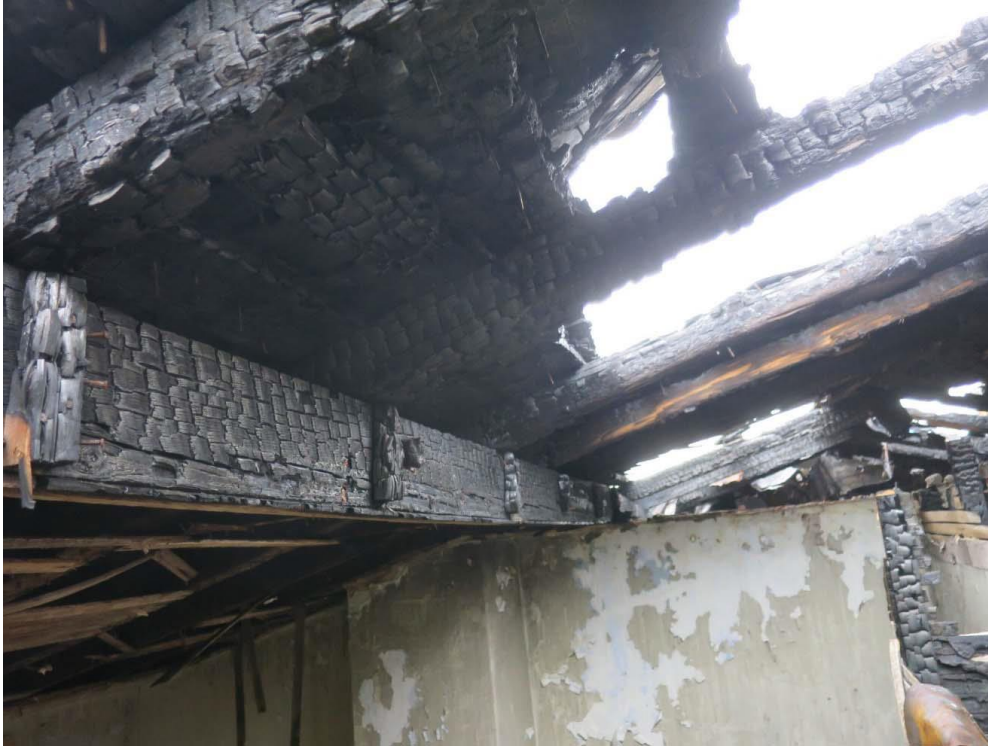
...The subject property was damaged by fire originating in 1133 Hollins Street. From our observations, it appears the fire breached the brick fire wall and burned the roof and all floors of the subject property... The fire damaged approximately 10% to 20% of the joist depth and width on impacted joists. Floor and sheathing was similarly impacted. Water damage was also evident and can be more deleterious to wood.

*Image 14:* 1135 Hollins Street, Roof damage and breach in fire wall, Engineering & Building, January 15, 2019, correspondence

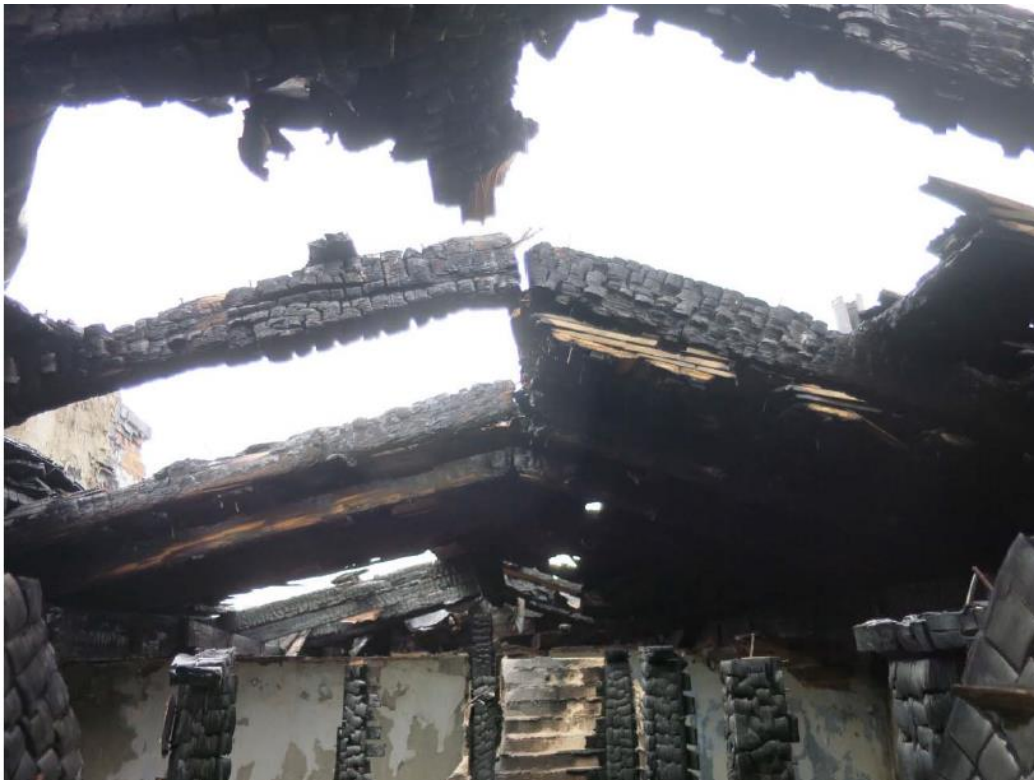
We estimate 100% of the roof structure is beyond restoration and must be removed. It is our opinion that the existing wood floor structure is not suitable for re-use, due to fire and/or water damage or under-sized per

*Image 15:* 1135 Hollins Street, 100% loss of roof structure, Engineering & Building, January 15, 2019, correspondence

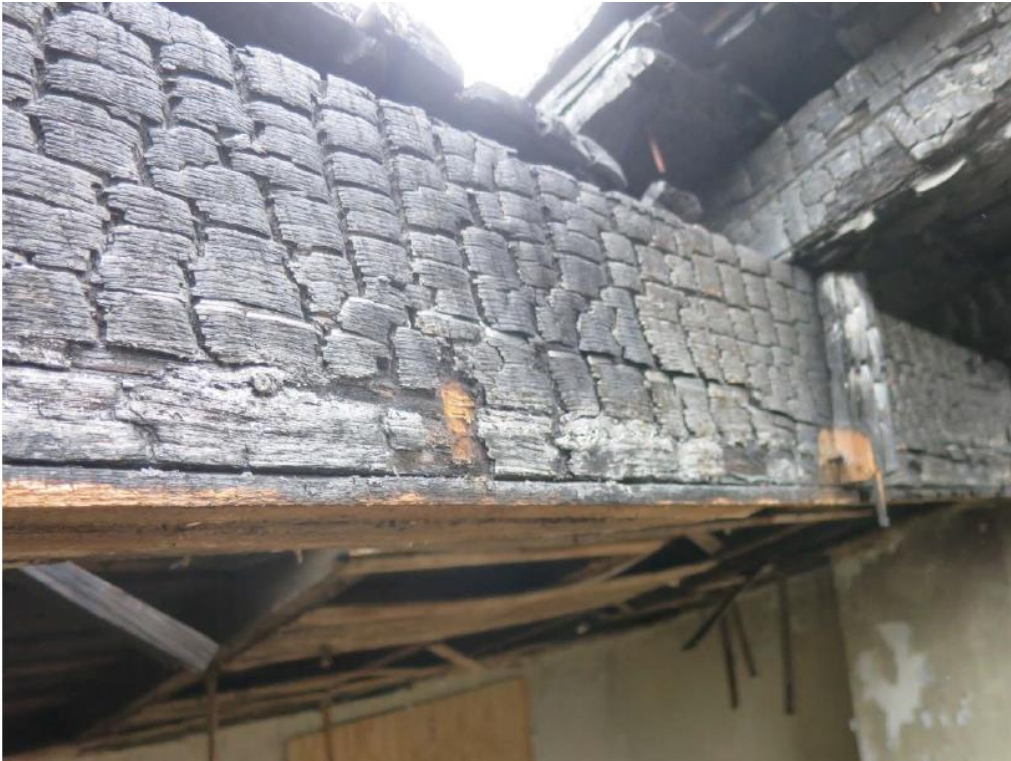
*Image 16:* 1135 Hollins Street, Roof beam with approximately 15% section loss, Engineering & Building, January 15, 2019, correspondence

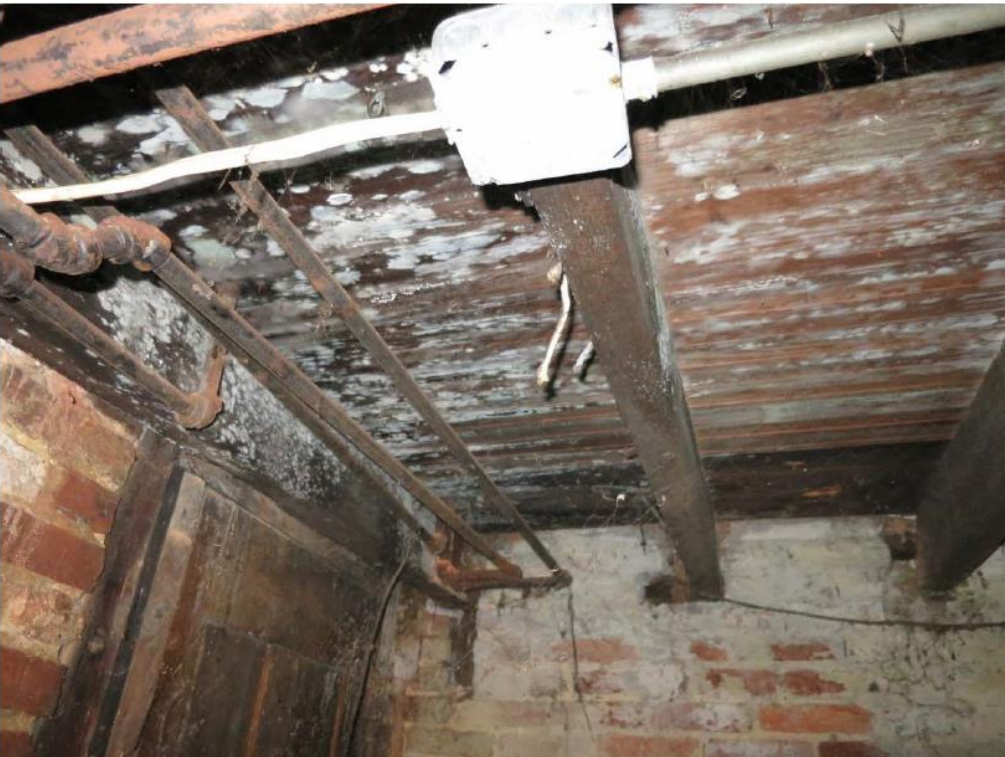
*Image 17:* 1135 Hollins Street, First floor framing with extensive water damage, Engineering & Building, January 15, 2019, correspondence

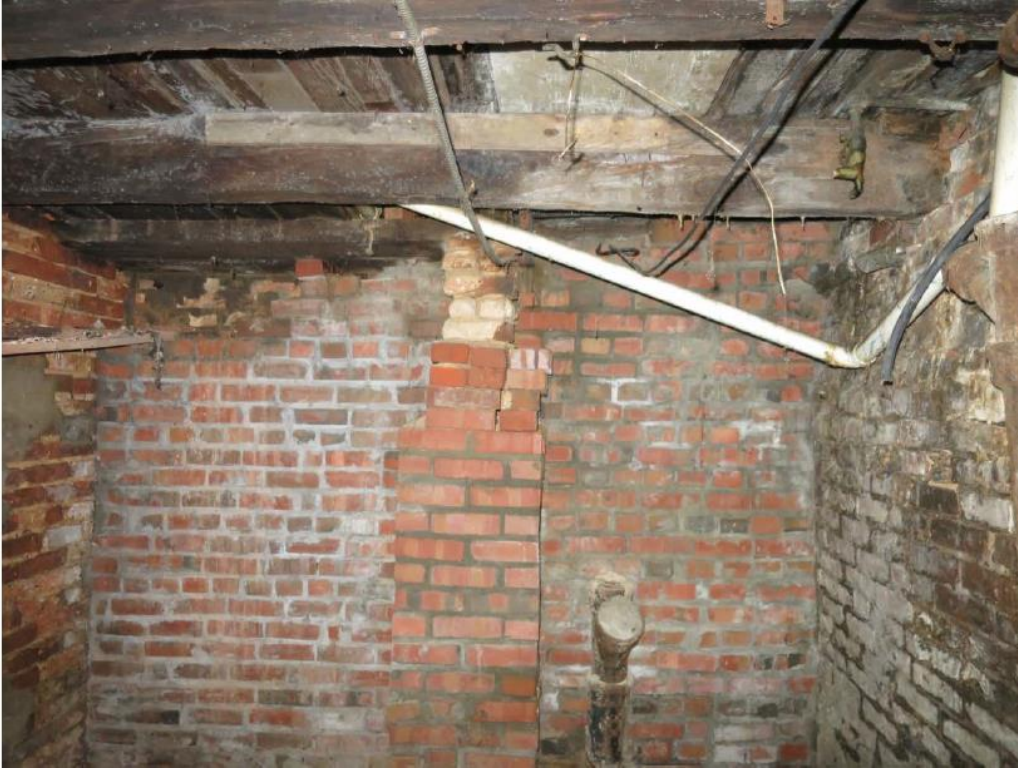
The basement is defined by single and multi-wythe brick masonry foundation walls. There are numerous areas where the brick masonry is unstable, spalled, missing bricks, and deteriorate (sic) mortar throughout. Basement floor is partial concrete and compacted in-situ soil.

*Image 18:* Unstable foundation walls with deteriorated masonry buttress/pier, Engineering & Building, January 15, 2019, correspondence

current code, and all wood framing must be completely removed... Foundation walls are unstable and must be rebuilt/repared prior to reconstructing the superstructure...(Images 14-19).<sup>2</sup>

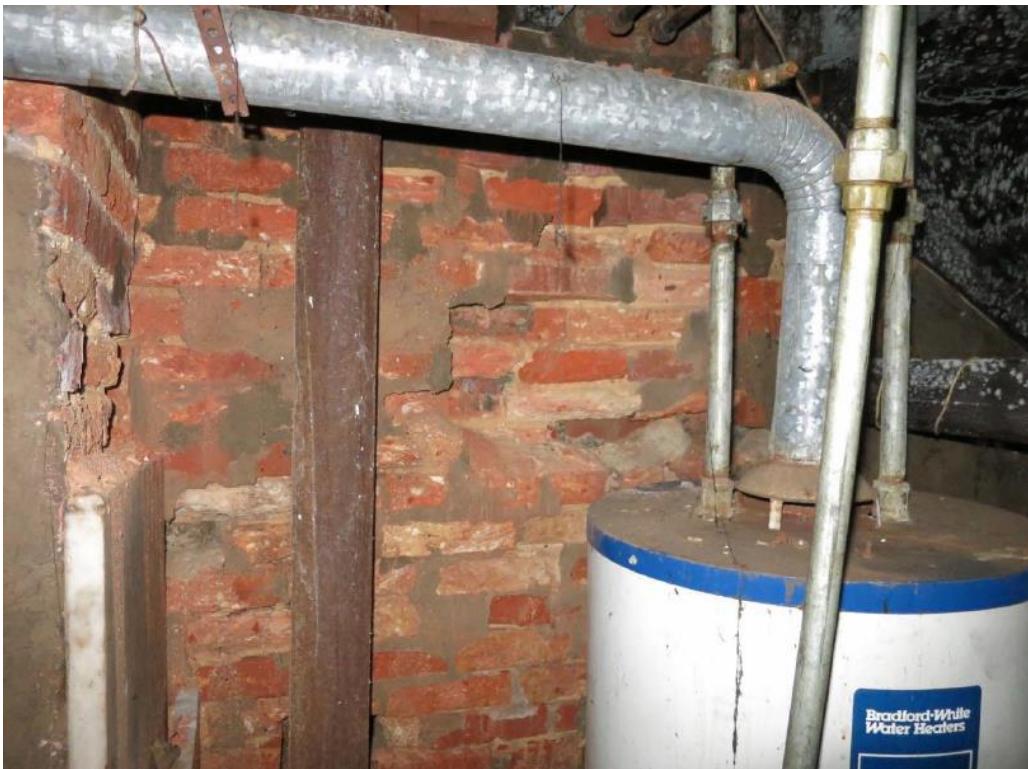
*Image 19:* Evidence of movement in foundation wall, deteriorated mortar prevalent, Engineering & Building, January 15, 2019, correspondence
